**Community Preservation Committee
Request for Funding
Rehabilitation of the Whittemore-Robbins Carriage House**

Structural Assessment Report
from
MacLeod Consulting
and
Curriculum Vitae, Arthur McLeod

MacLeod Consulting, Inc.

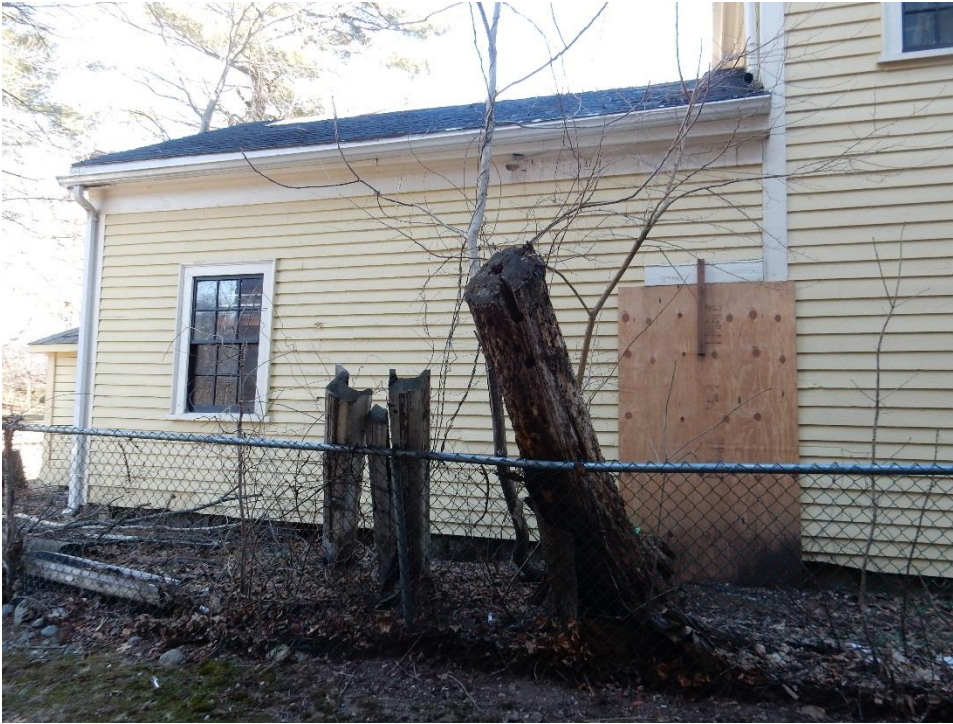
5. West end of South face of Whittemore Robbins Carriage House. Plywood panel propped against a rotted hole in the wall. Note: lintel trim is present that suggests a former wall opening.

9. One-story wall framing and sheathing. The rear wall behind the middle garage bay is significantly deteriorated. Remove rotted framing and sheathing here and replace in kind.

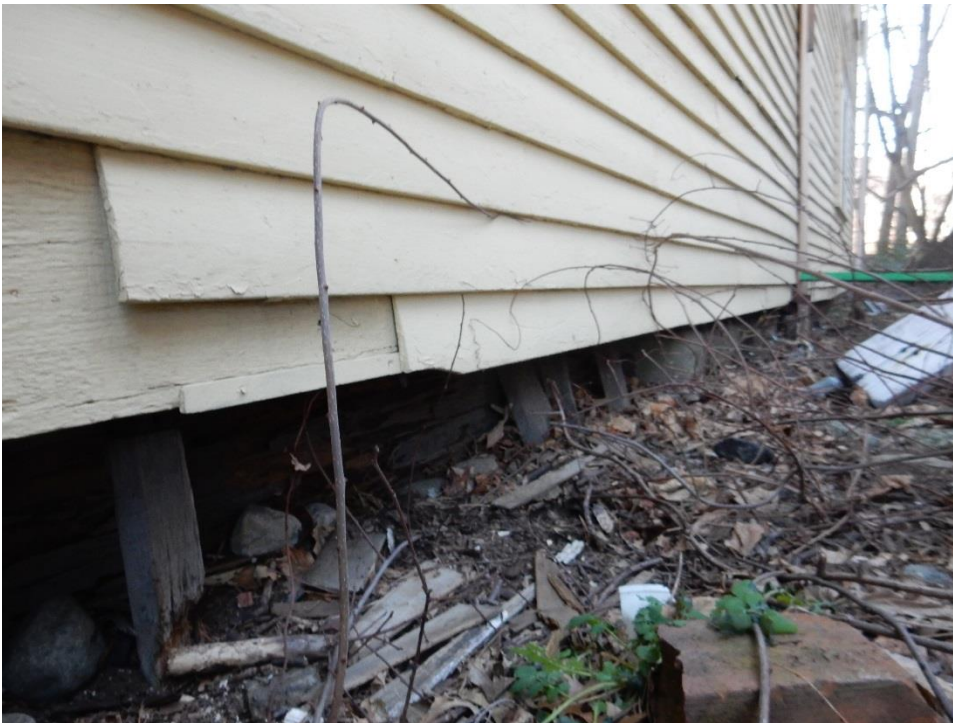
8. Missing sections of clapboard siding and course of cinder block foundation.

5. Foundation in general. Pointing mortar is missing in the cinder block. Repoint the head joints of the cinder block.
6. One-story foundation. The cinder block foundation is missing in the southwest end of the building. Clean out debris and replace with concrete block.

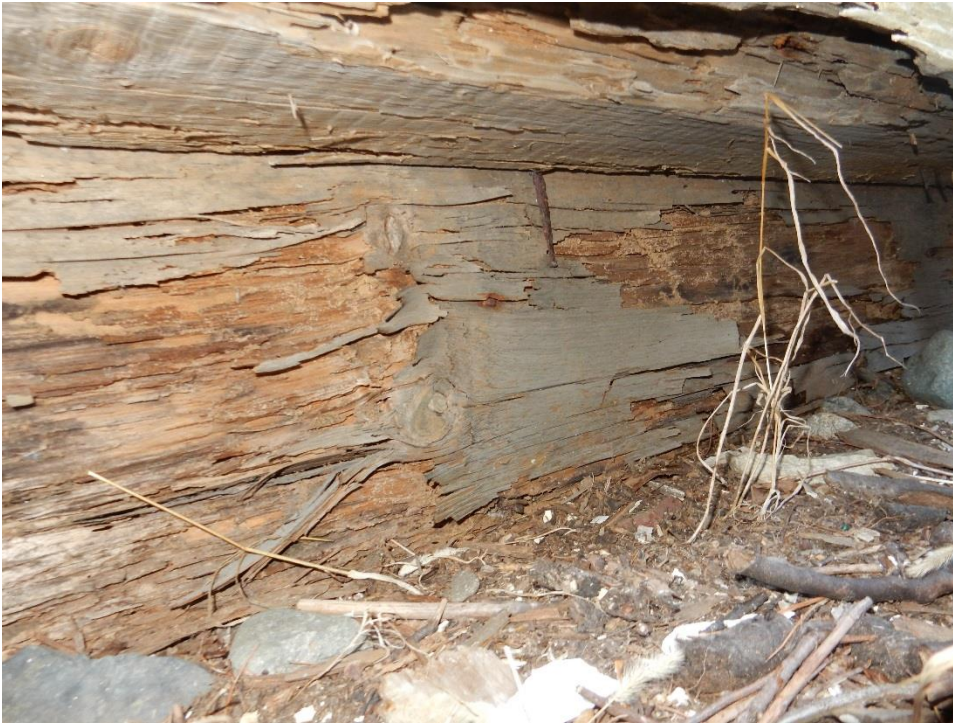
9. At south face of one-story area, cinder block foundation which caps rubble foundation and supports wood sill is missing. The vertical board appears to be the backside of a nailer that supports interior board finishes.

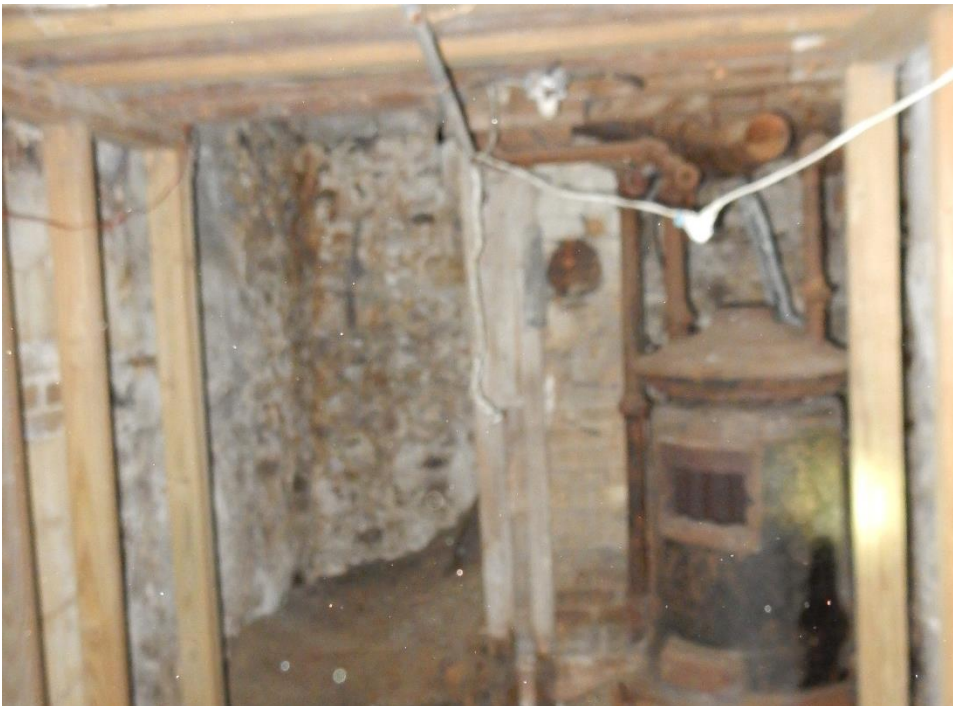
10. View within basement that fits under a small portion of the first floor. Wood studs along two sides support closely spaced planks to shore the concrete slab. Chimney and abandoned boiler in background.

2. Two-story first floor shoring. In the basement, wood walls bearing directly on soil support closely spaced joists to shore an existing concrete floor slab. This is a temporary stabilization. This wood shoring should be replaced with a permanent steel structure.

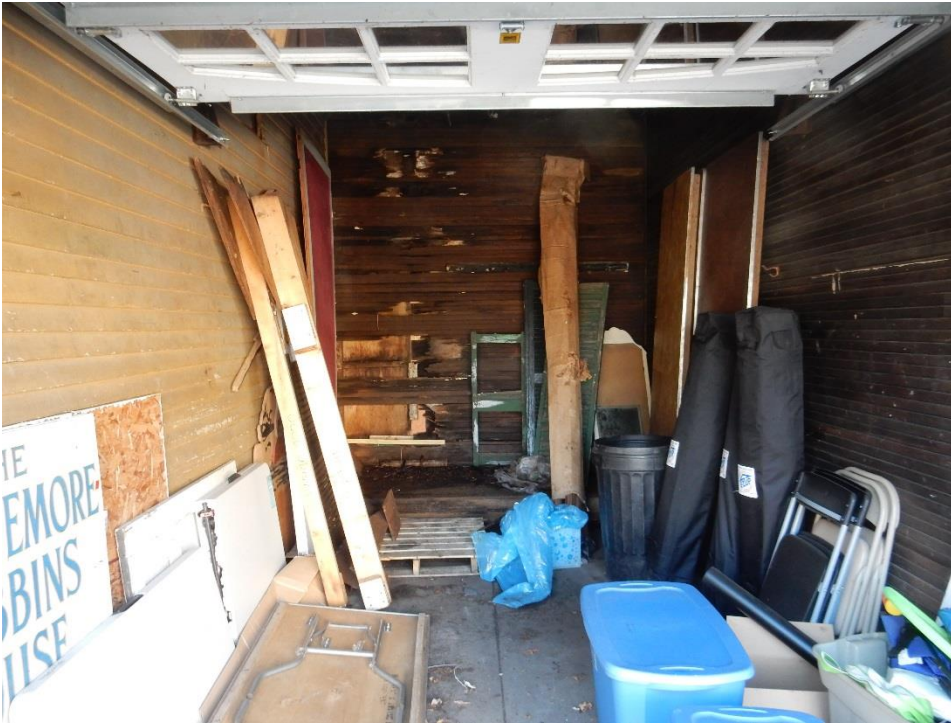
11. Bay in one-story portion next to two-story area. Rear bead board facing is heavily rotted. Some evidence of mold is present in the bead board on the wall separating the west most bay. Raised platform in background is covered with rotted debris.

7. One-story raised floor. The raised floor in the middle garage bay is built on a concrete slab on grade and is covered with rot debris. Remove it.
8. One-story loft framing. In the right most garage bay, an ad hoc loft is used to store tables, ladders, building materials, and boxes. The loft is too flimsy for such use. Remove the loft.

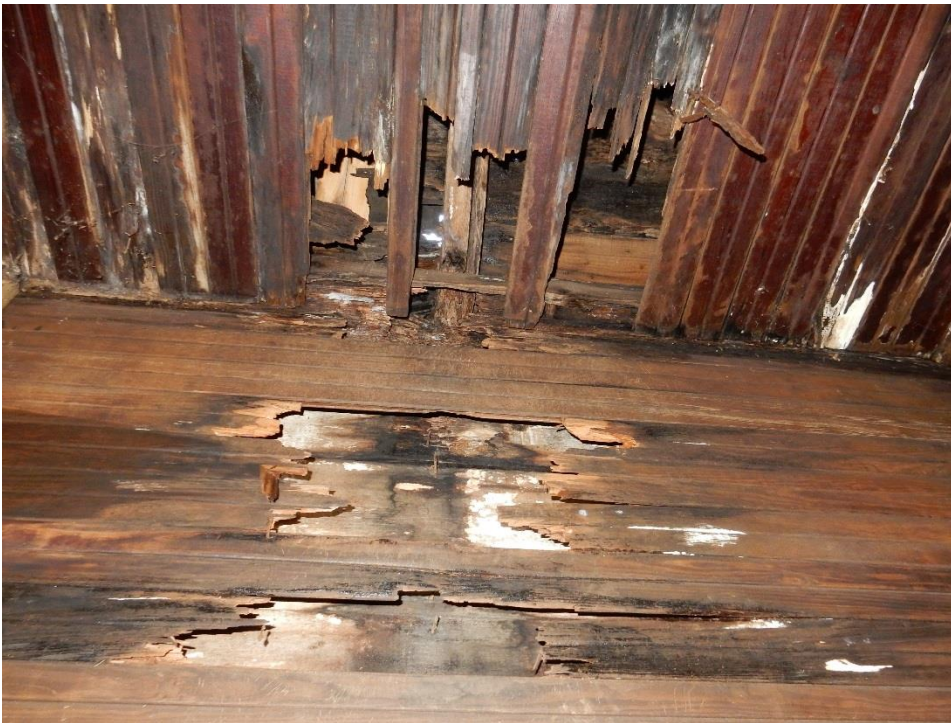
12. Soffit bead board in the aforementioned bay is rotted near the rear wall.

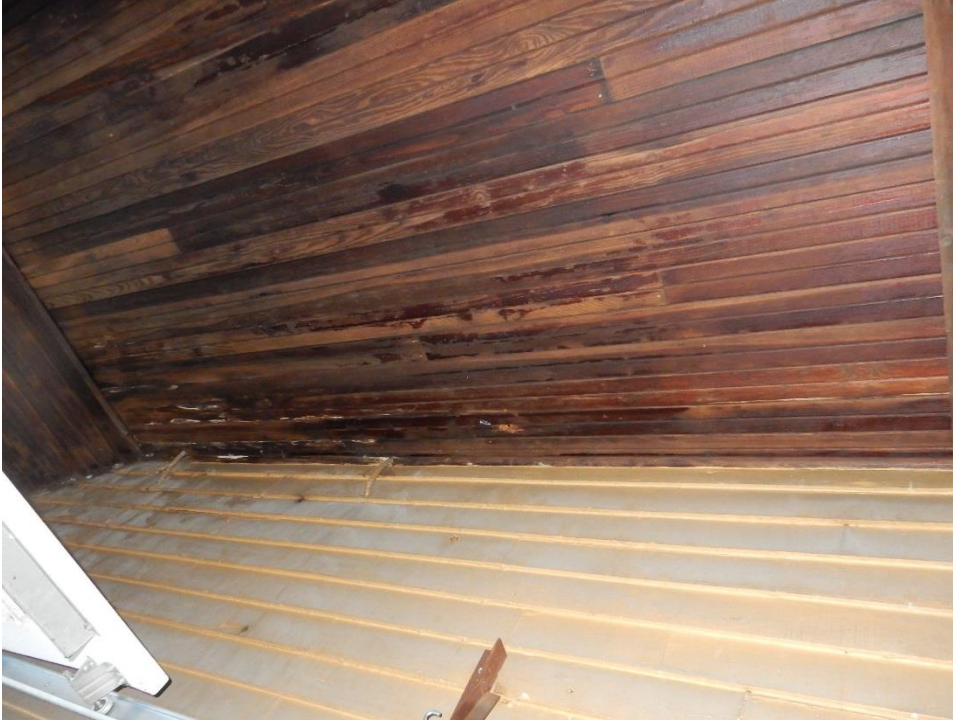
13. Soffit bead board in the aforementioned bay holds mold next to the two-story area toward the front wall.

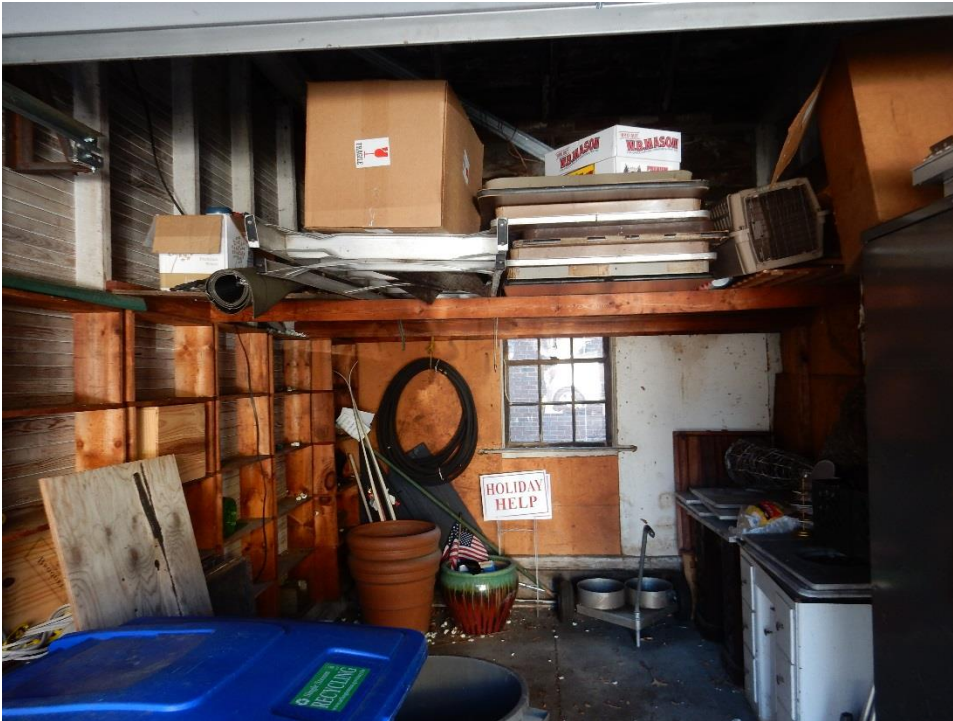
14. West most bay in one-story portion. Area is dry. A makeshift loft supports storage.

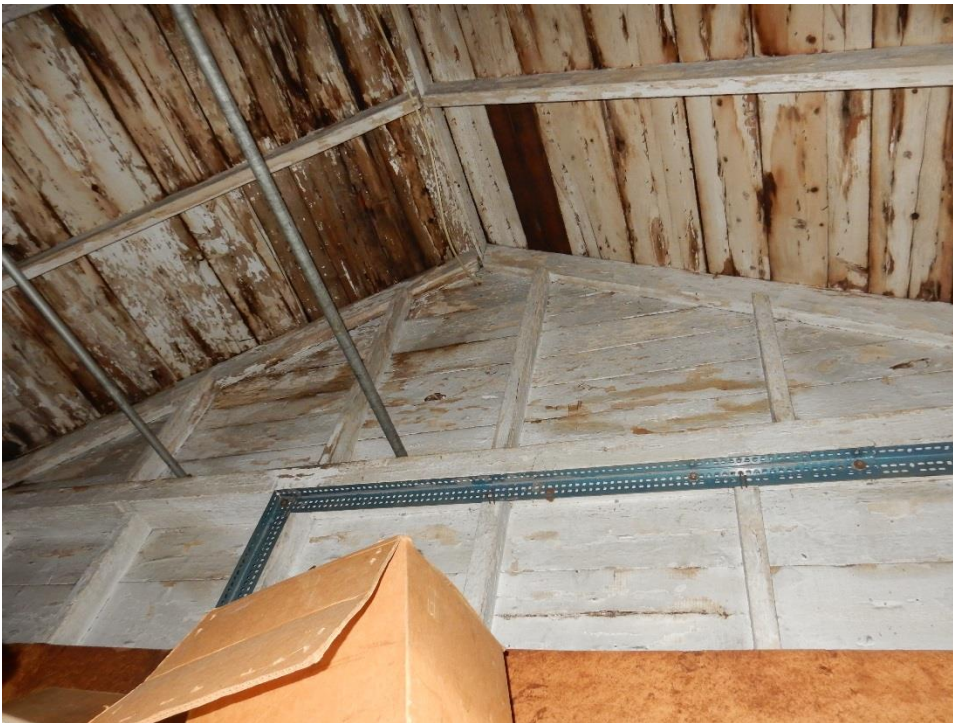
16. Gable wall and roof framing over aforementioned bay. Rafters appear intact. Board sheathing is stained from past moisture.

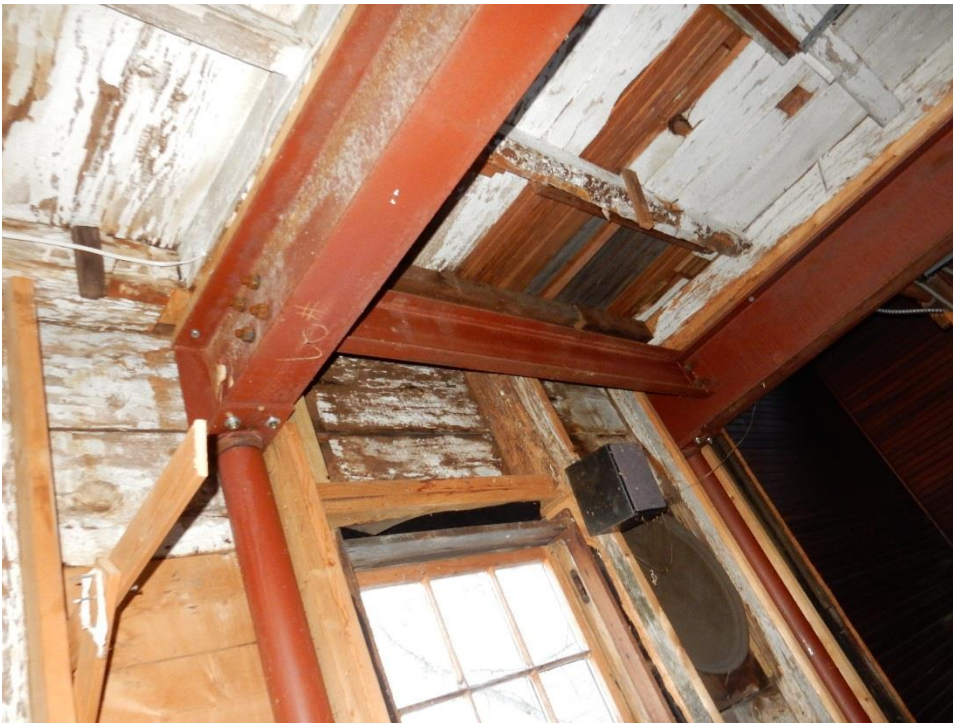
18. Underside of second floor framing in two-story building. Steel beams are supported on pipe columns next to stairs.

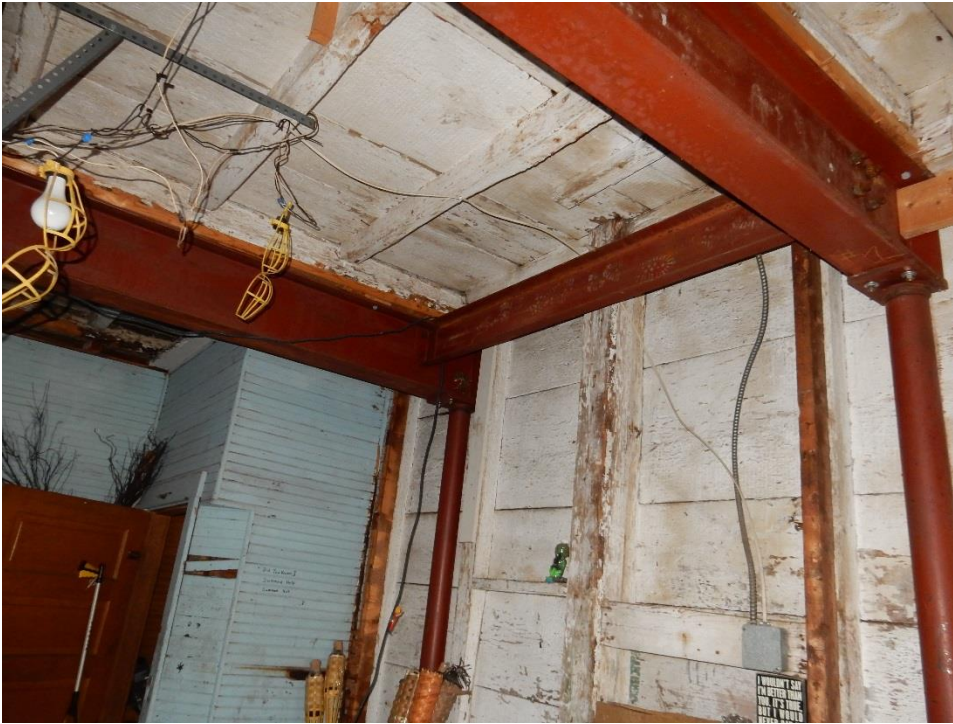
19. Underside of second floor framing in two-story building. Steel beams are supported on pipe columns in wall next to one-story building.

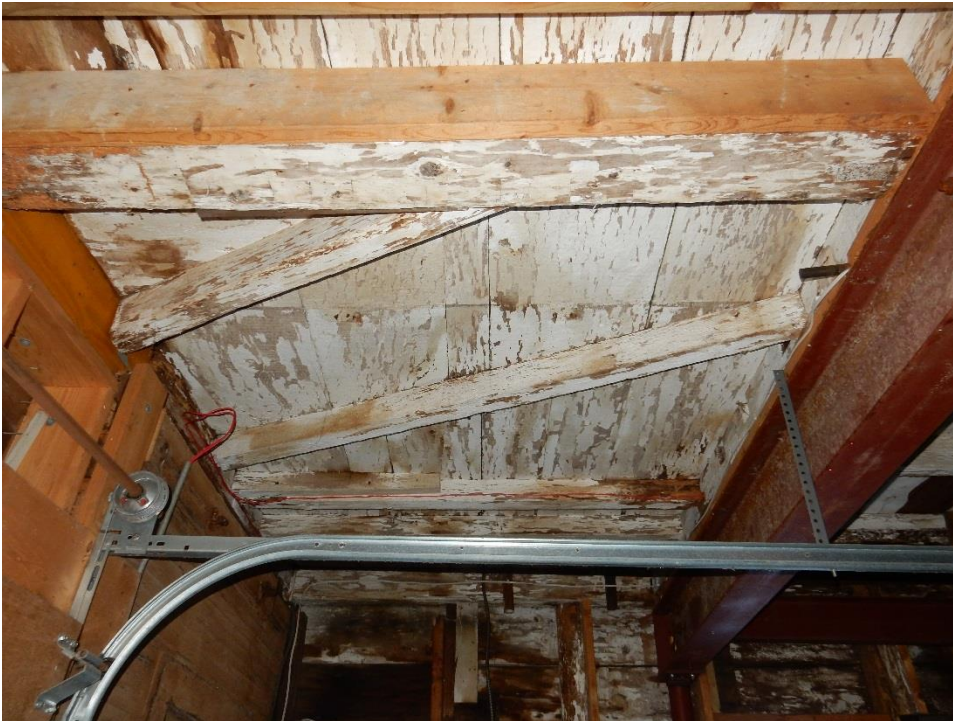
20. Mislocated second floor wood joists which appear to have been moved when installing steel shores now not adequately supporting board flooring.

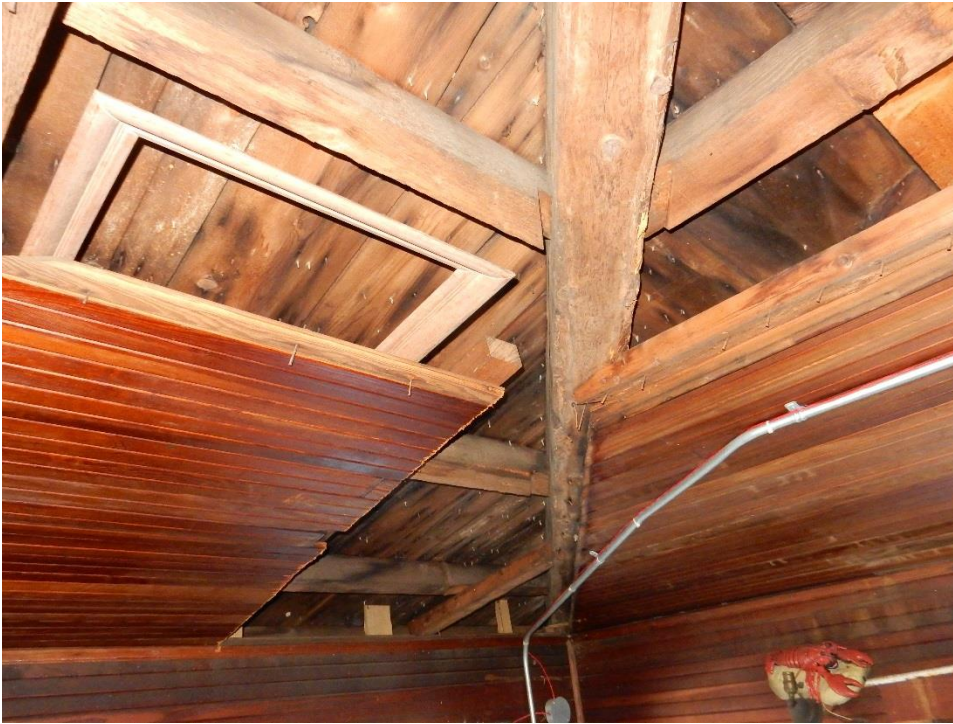
21. Underside of two-story building roof. 3x4 purlins are supported on 5x5 hip beams. Ceiling and walls originally covered with bead board.

4. Two story roof purlins. The roof is framed with wood purlins that span to hip beams. The center beam, the ridge beam, is adequately shored to the steel shoring below. Some of the purlins near the northwest corner of the original building are somewhat rotted from persistent leaks. These should be replaced with new purlins.

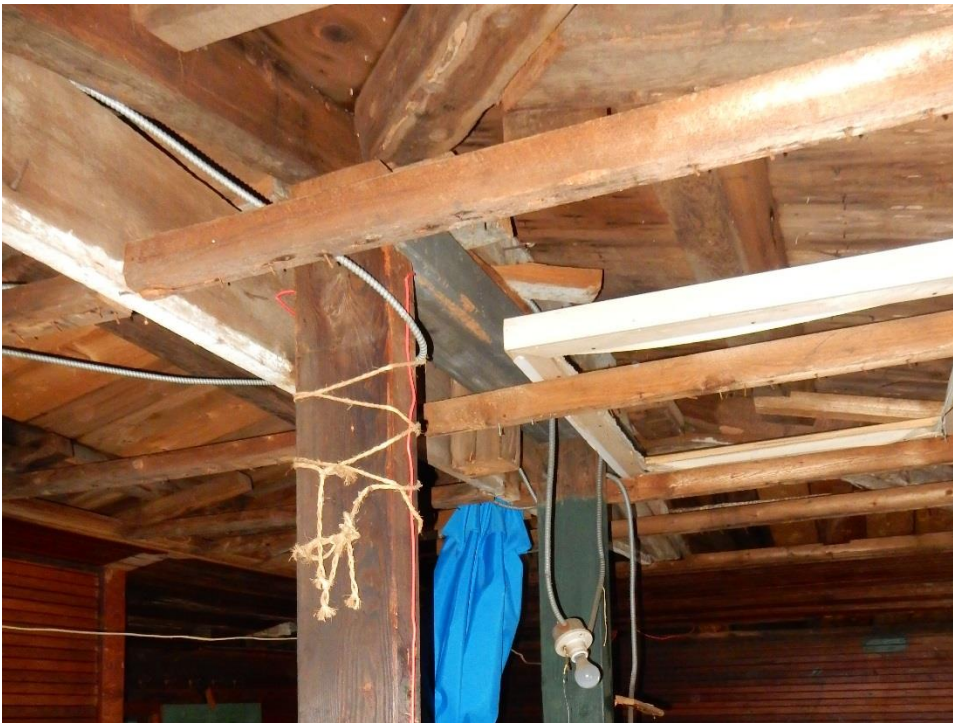
22. Two wood shoring posts support the ends of a 5x5 ridge beam. Ridge beam has a 2x10 lapped and nailed to the sloping 5x5 rafters that align with the ridge beam. This formed a makeshift truss and was the main support for the roof.

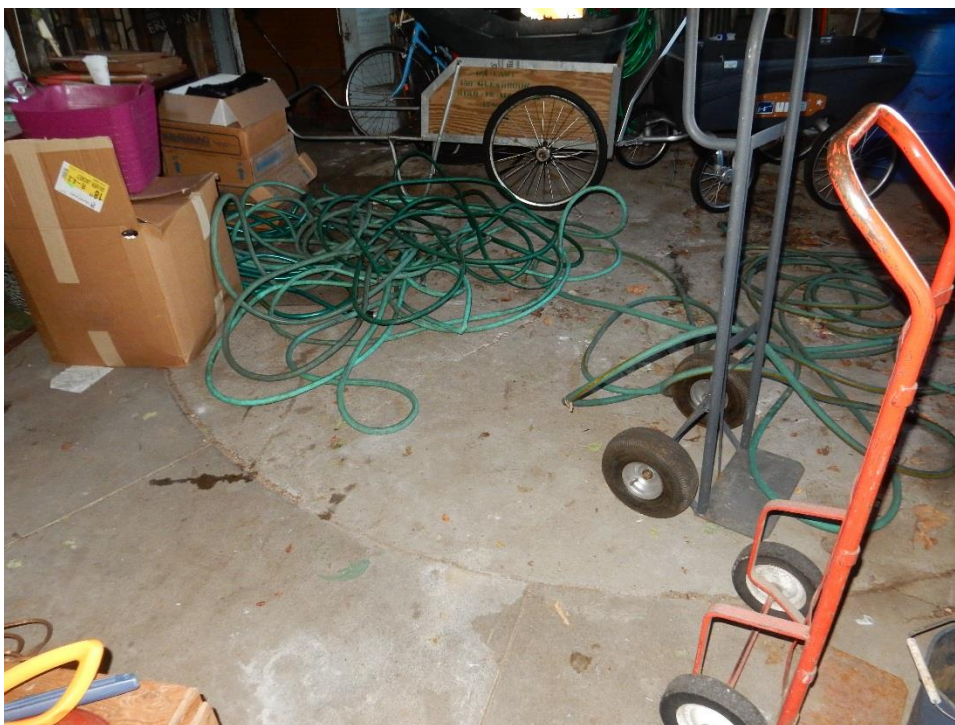
23. Remnant of former car turntable. Surrounding concrete floor appears original. Circular infill concrete appears tight to surrounding concrete, more recent, and not operable.
